OPT and AST Series Transfer Switch Technical Bulletin

MAN-0102 Rev 1.1
September 25, 2014

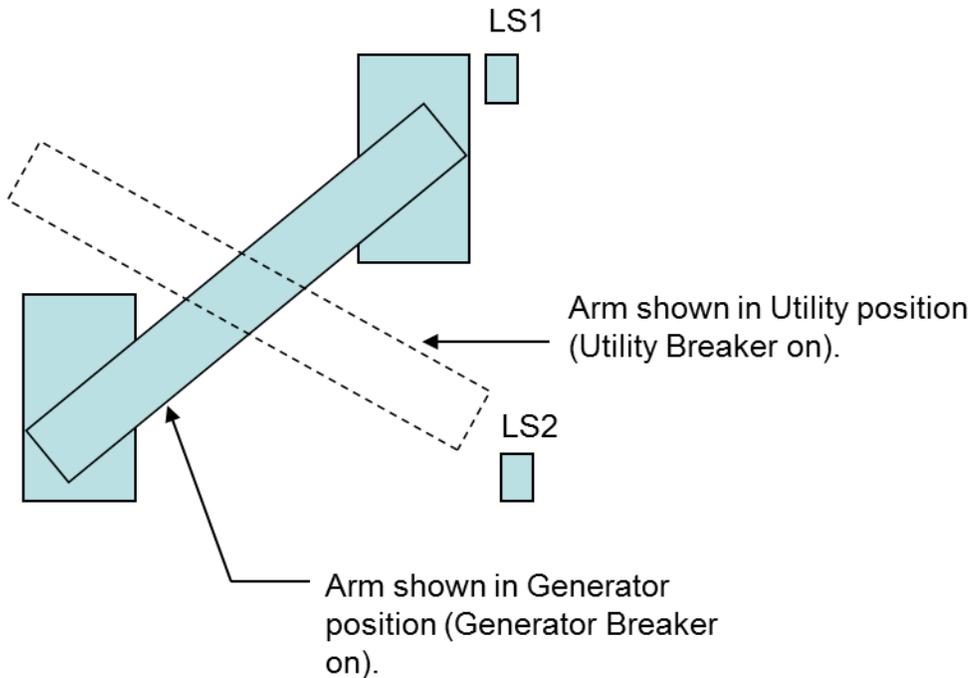
Figure 1 – AST/OPT Transfer Arm

Basic principle of switch operation is a lever arm rotates to switch on the generator breaker or utility breaker. This is done by a Motor [M] that rotates in one direction only.

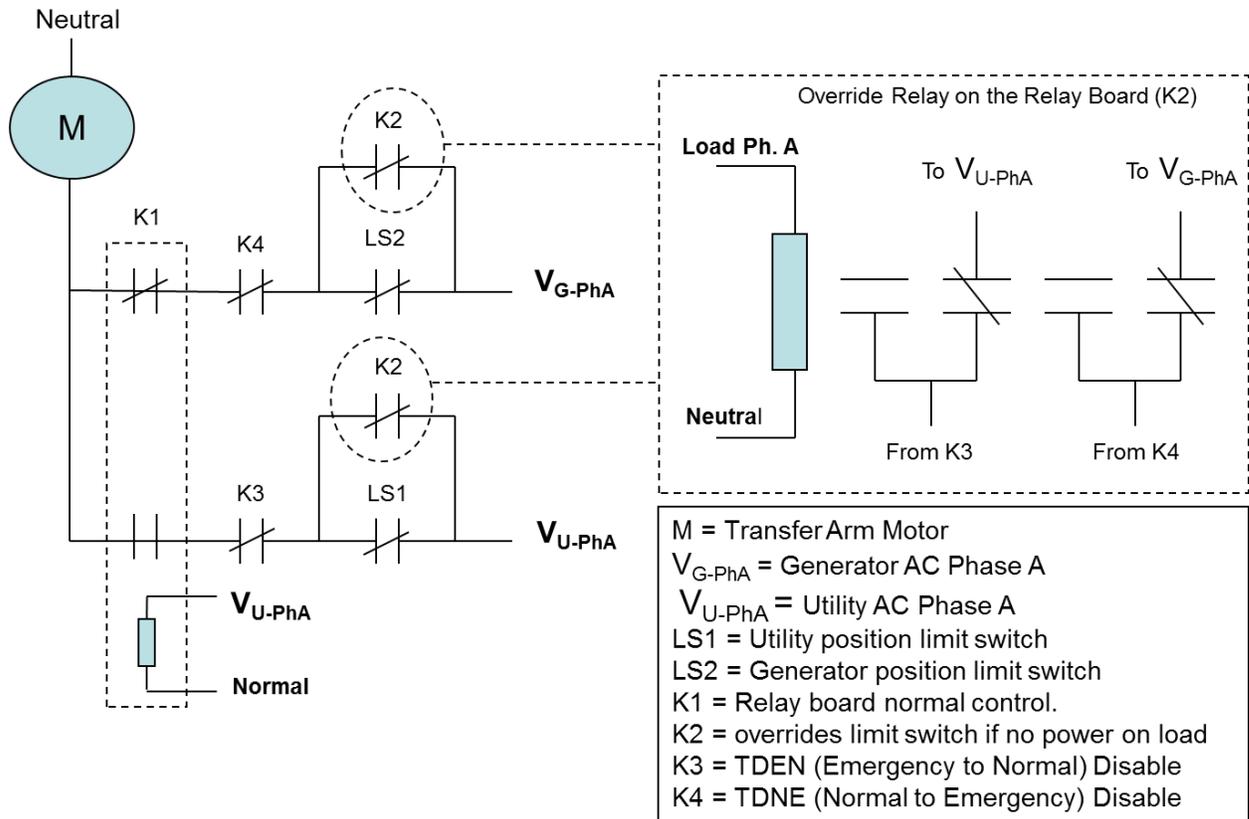
Figure 2 – RB41 Schematic

Contact [K1] initiates motor movement to transfer to emergency or utility based on utility phase A voltage. An external controller (e.g. TSC3) can delay the transfer by outputting high on contacts K3 and K4 which opens the relay keeping the motor off. If no external controller is connected transfer begins immediately.

Limit switches [LS1 and LS2] are responsible for stopping the motor when the lever arm is in the correct position. Power to the motor is obtained from either the utility or generator side depending on direction of transfer.

If load is not detected when the lever is in the correct position another relay on the relay board [K2] overrides the limit switch to allow the motor to continue to rotate to attempt to turn on the breaker.

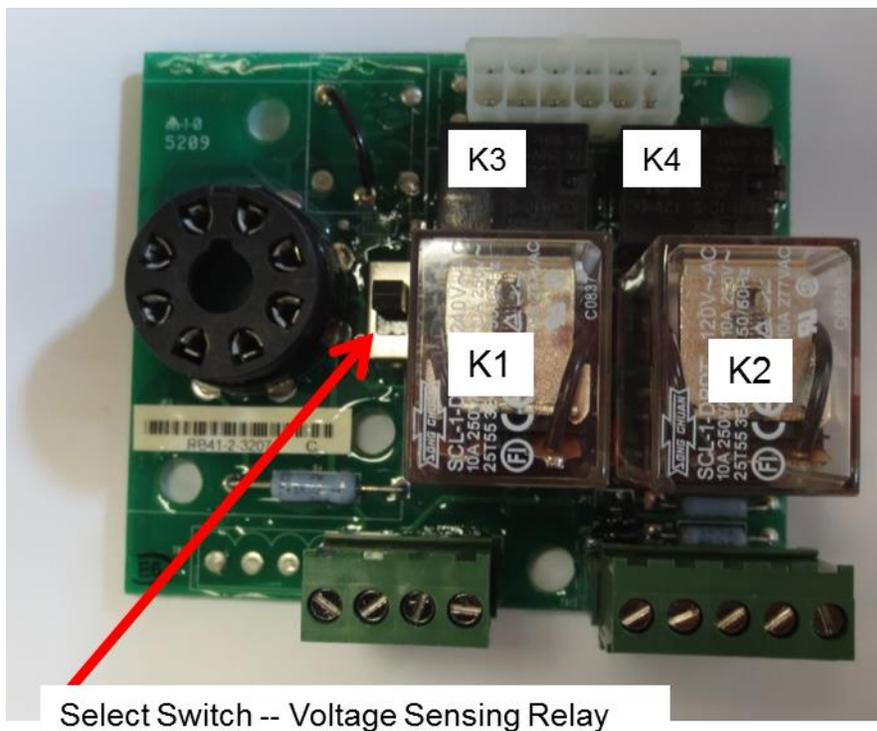
Figure 3 – RB41-2

See below for photo of RB41-2. RB41-3 is identical except it uses a larger Molex connector (the white connector).

The slide switch (select switch) must be in the off position (towards the white Molex connector) if the voltage sensing relay is not being used. Otherwise if there is no relay in place the RB41 will think there is a utility fault and attempt to switch to emergency.
